VENTILATING CATHEDRAL CEILINGS TO PREVENT PROBLEMATIC ICINGS AT THEIR EAVES

WAYNE TOBIASSON, THOMAS TANTILLO and JAMES BUSKA

Cold Regions Research and Engineering Laboratory (CRREL) Hanover, New Hampshire, U.S.A.

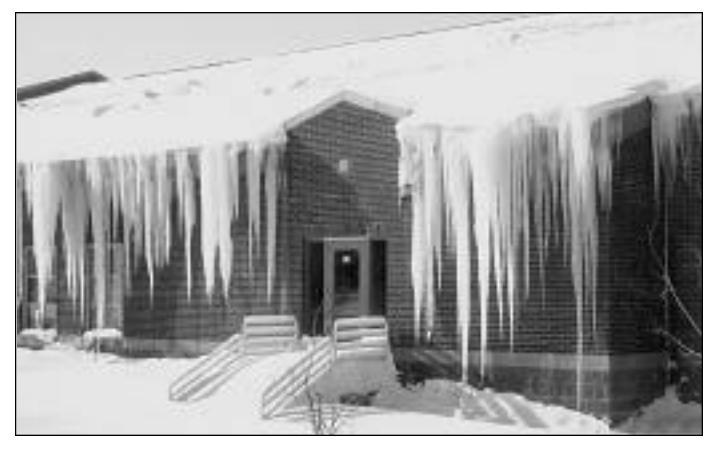
Figure 1. Severe icings along the eaves of a poorly ventilated roof.

When building heat melts the bottom of snow on a sloping roof in cold weather, the meltwater runs downslope to the cold eaves, where icings and ice dams are created (Figure 1). Adding insulation to the roof reduces the amount of heat available to melt snow, but even well-insulated roofs can suffer icing problems because snow is a good insulator. For example, a 70°F (21°C) building with an R30 roof that is covered with 12 inches (305 mm) of snow, which has an R value of 1 ft²h°F/Btu per inch (6.9 mK/W) (i.e., a total R-value of 12 ft²h^oF/Btu [2.1 m²K/W]), will experience melting at the base of the snow pack when the outside temperature is 17°F (-8°C) or higher. Only when the outside temperature is lower than 17°F (-8°C) will the base of the snow on that roof be below freezing. With more snow on the roof, the likelihood off creating icicles and ice dams increases. Thus, insulation alone, while playing an important role in reducing icings, has limitations.

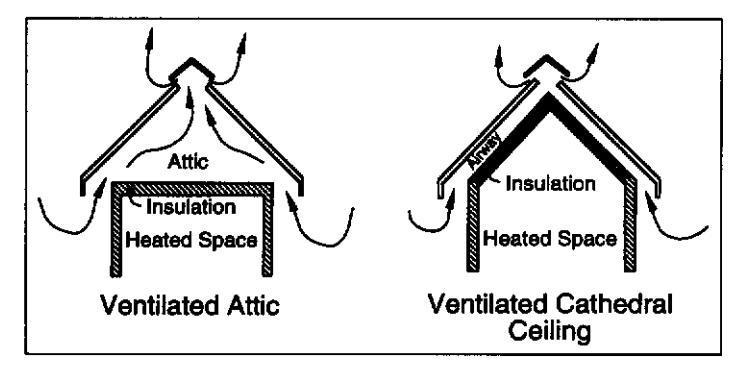
Figure 2. Ventilated attics and cathedral ceilings.

The attic guidelines cannot be used without adjustment for cathedral ceilings, because the narrow airways created above the insulation in such roofs (Figure 2) offer considerable resistance to airflow. However, we have used these guidelines with success to determine the size of attic ventilation systems, then multiplied them by three to five to size the airways of cathedral ceilings [3].

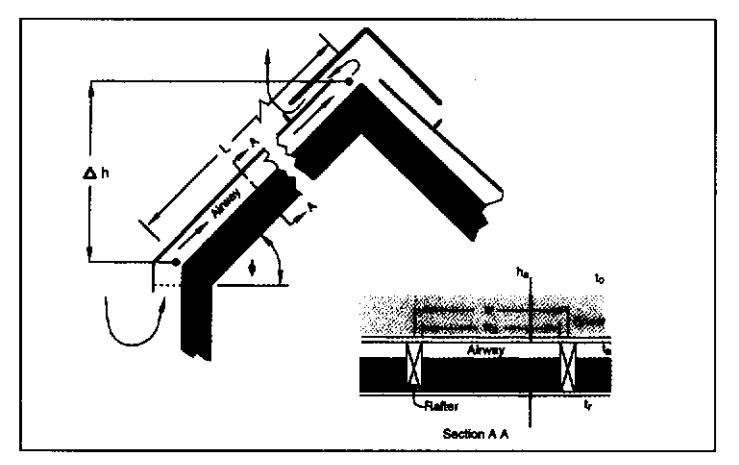
Figure 3. Roof and airway dimensions.

Figure 3 shows various roof and airway dimensions. The following mathematical relationships were developed from equations in the 1997 Fundamentals volume of the *ASHRAE* (American Society of Heating, Refrigerating and Air-Conditioning Engineers) *Handbook* [4]. Specific ASHRAE equations used are shown in brackets. For example, [C3E11] refers to Chapter 3 Equation 11 in that reference.

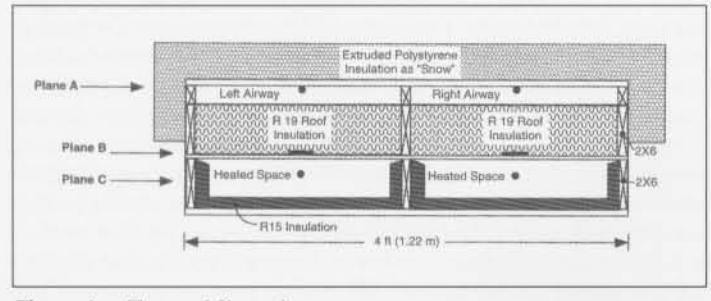
Figure 4a. Test roof dimensions.

To validate the applicability of the equations in the previous section, a test roof with two side-by-side, 21^{3/}-inch-(0.55-m-) wide, 16-foot- (4.9-m-) long airways was built in a coldroom at CRREL. The two airways could be configured differently and their heights could be varied. Figure 4 shows the dimensions of the test roof and where it was instrumented. Extruded polystyrene insulation boards were used to simulate the insulating value of snow on the roof.

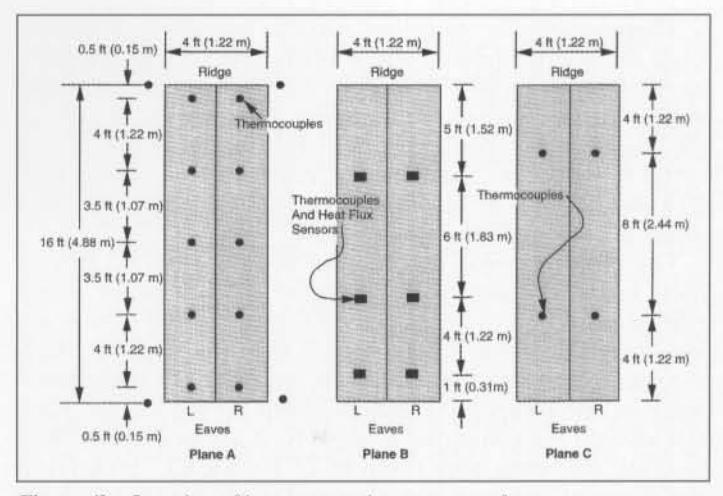
Figure 4b. Location of instrumentation on test roof.

As shown in Figure 4, temperatures were measured at five places along the top of each airway from its eaves to its ridge. Figure 8 shows three typical temperature profiles. A uniform increase in temperature is evident along two of the airways, except near the ridge. The temperature sensor in each airway near the ridge was 6 inches (152 mm) in from its end. It consistently was colder than would be expected from the trend defined by the other four sensors in the airway. It appears that a loop of cold air was entering the airway at the ridge under the out-flowing warm air, cooling the last few feet of the airway. We have used a straight line extrapolation of information from the other four sensors in each airway to define the temperature expected at the top of the airway (hereinafter called the "exit temperature"). If the exit temperature exceeded 32°F (0°C), that airway was considered to be inadequate, since snow on the roof above would be melted, causing icings at the eaves.

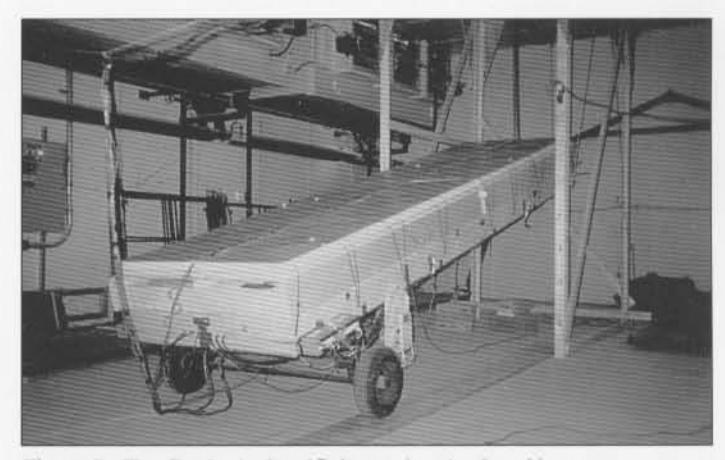
Figure 5. Test Roof raised to 15 degree slope in the coldroom.

Figure 5 shows the test roof supported on a stripped down boat trailer. The tower also shown in that figure was equipped with a chain fall that allowed one end of the roof to be raised to create slopes up to 44 degrees. Tests were run at slopes of 0, 15, 30 and 44 degrees. In Figure 5 the roof is at a slope of 15 degrees. In Figure 6 it is at a slope of 44 degrees.

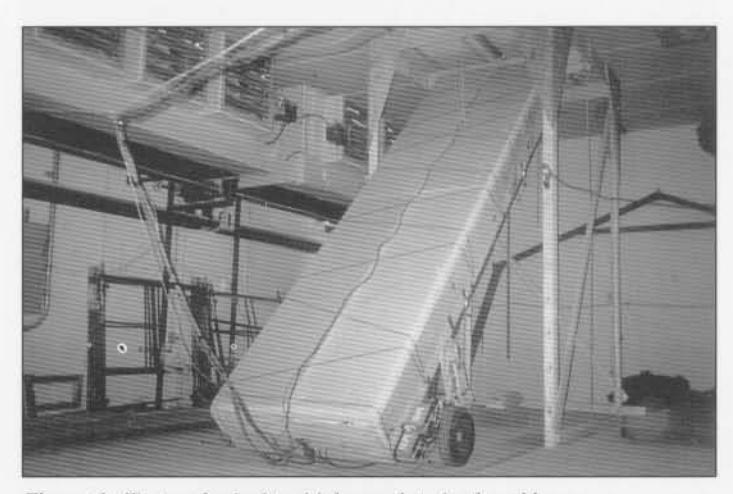
Figure 6. Test roof raised to 44 degree slope in the coldroom.

The "snow" insulation boards were held in place with bungee cords as shown in Figure 6. Those insulation boards were tight against the roof, but in hindsight, they also should have been sealed to it and each other with tape. The heat flux sensors and thermocouples indicated that the <u>net</u> insulating ability of those boards was only one-half to twothirds of the thermal resistance of the boards themselves. Air movement at the seams and between them and the roof below is considered to be the cause of the reduction. We intended to run most of the tests with the equivalent of about 15 inches (381 mm) of snow on the roof to represent the "worst-case" condition of very little heat loss (and cooling of the airway) up through the snow. Because of air gaps between the roof and the "snow" insulation, we succeeded in creating only a moderate (about 6 inches [152 mm]) snow cover. Thus, these test airways did not get quite as warm as the worst case. Because of this shortcoming, these tests more closely represent lesser, "real-world" snow covers.

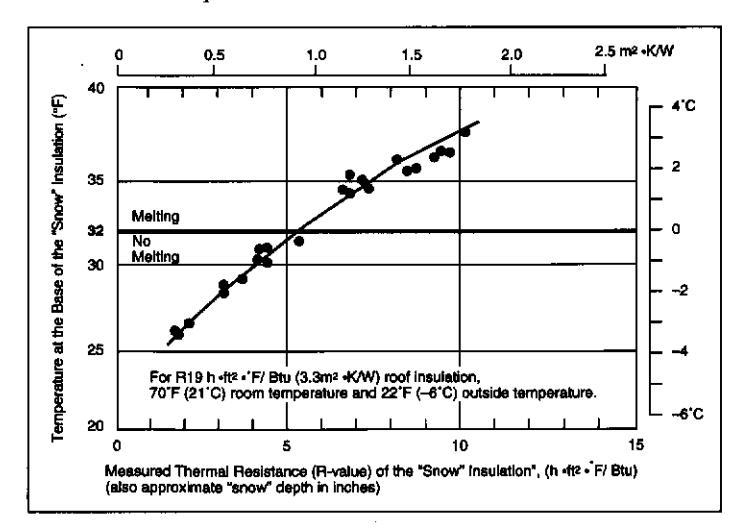
Figure 7. Measured and calculated temperatures of "snow" on the test roof.

Figure 7 plots the net insulating ability of the "snow" for tests with no airway vs. the temperature at the base of the "snow." Assuming that the thermal resistance of snow is about 1 ft²h°F/Btu per inch (6.9 mK/W), we can also think of the R-value shown in Figure 7 as snow depth in inches. The curving line in that figure is the trend line for those data points. Figure 7 indicates that, for these conditions (heated space at 70°F [21°C] and R19 [3.3 m²K/W] insulation in the roof), it takes very little "snow" (only about 5 inches [about 130 mm]) to raise the temperature at the base of the snow above its melting point (32°F [0°C]) at the design condition (22°F [-5.6°C] outside). As more snow is present on the roof, the temperature at the base of the snow increases. The temperature there stays lower for roofs containing more insulation. However, for a roof with a thermal resistance (R-value) of 40 ft²h°F/Btu (7.0 m^2K/W), problematic melting can occur when just a foot of snow is present.

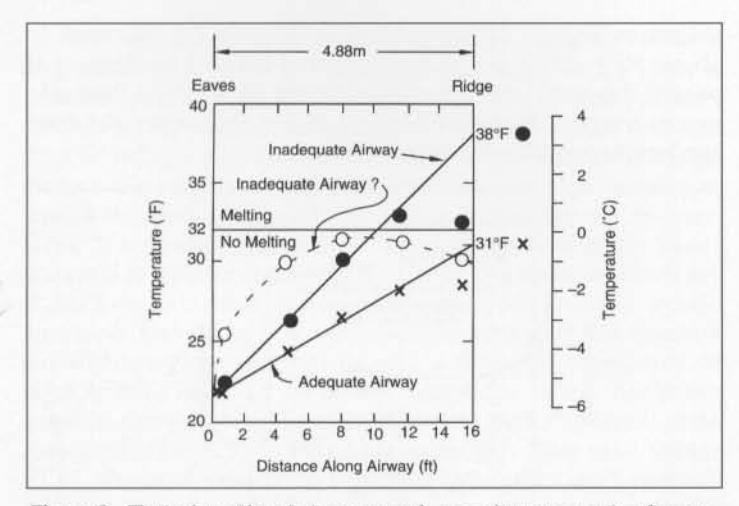
Figure 8. Typical profiles of airways tested: one adequate, two inadequate.

The airway represented by the upper straight line in Figure 8 ($h_a = \frac{1}{2}$ inch [13 mm], slope = 44 degrees) had an exit temperature of 38°F (3.3°C) and thus was inadequate. The airway represented by the lower straight line in Figure 8 ($h_a = 1$ inch [25 mm], slope = 30 degrees) had an exit temperature of 31°F (-0.6°C) and thus was big enough to avoid snow melt and icings.

The third temperature profile shown in Figure 8 ($h_a = \frac{1}{2}$ inch [19 mm] slope = 15 degrees) does not display the linearity that the others do. Those data points are connected by a curving dashed line to show this. This type of non-linear temperature profile was present for some airways, most either blocked, narrow or low slope.

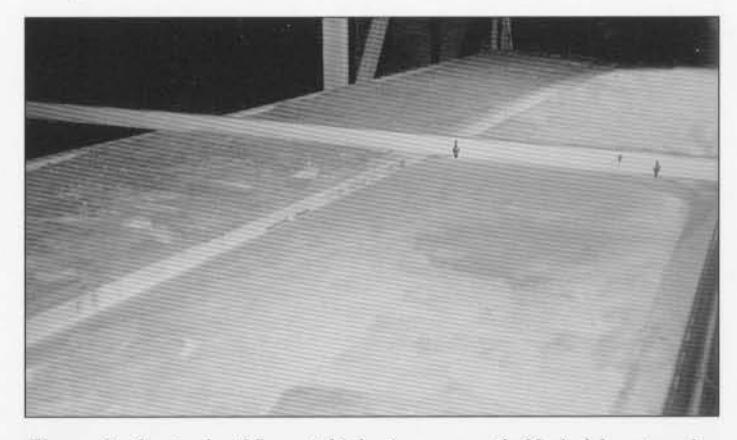
Figure 9. One-inch- (25-mm-) high airways mostly blocked by expansion of fibrous glass insulation.

The batt insulation without the air barrier over it expanded to fill the 1-inch- (25-mm-) high space intended to be an airway. We had expected some expansion, but we did not expect this much.

The fibrous glass insulation in the adjacent airway was exerting similar expansion forces on the air barrier when we installed it. Had this air barrier been installed before the fibrous glass was installed, which would be the normal sequence on most real roofs, it is logical that it could have been installed somewhat tighter because no fibrous glass would be bowing it during its installation. We tried to install this air barrier very tightly, thus much of what we subsequently experienced can be expected, all things considered, on most real roofs. Figure 9 shows these two airways just prior to our placing the plywood roof deck on them. The unrestrained fibrous glass has risen more than 1 inch (25 mm) and is even forcing its way up around the straight edge, which rests on the top of the 1-inch- (25-mm-) high strips screwed to the "2 x 6" rafters to create the airway. The air barrier has also been forced up by the fibrous glass so that over most of the airway (between the two arrows on the straight edge) it is pressing against the bottom of the straight edge. Thus, the airway above the air barrier was of very limited size, and no airway existed when no air barrier was present.

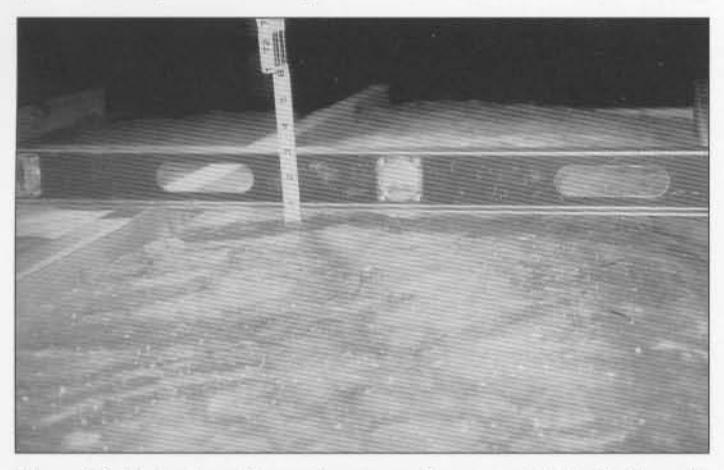
Figure 10. Expanding fibrous glass came close to completely blocking this 2-inch (51-mm) high airway.

We next increased the height of the spacers to 2 inches (51 mm). The fibrous glass without an air barrier continued to expand upward. As shown in Figure 10, it almost filled the 2-inch (51-mm) space intended to be an airway. Over the center half of the airway, it came within ½ inch (13 mm) of completely blocking it. This airway received some ventilation but exit temperatures were still quite high (35 to 39°F [1.7 to 3.9°C]).

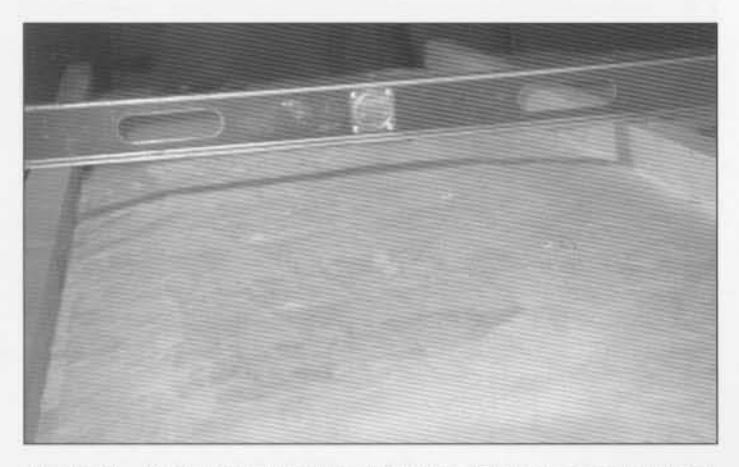
Figure 11. Air barrier reduced the intrusion of fibrous glass insulation into this airway.

In the adjacent airway, the air barrier resisted the fibrous glass expansion. As shown in Figure 11, at no place did this air barrier touch the underside of the roof deck. It was ¾ inch (19 mm) below the underside of the roof deck along the centerline of the airway.

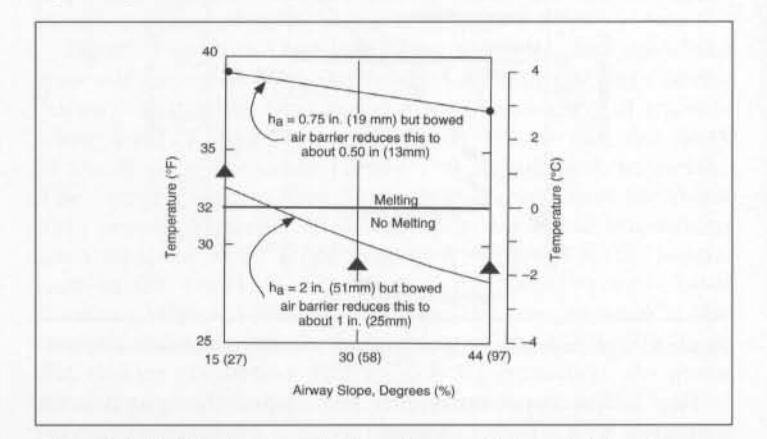
Figure 12. Exit temperatures for two airways with bowed air barriers.

Results for this and another airway with an air barrier are presented in Figure 12. At a slope of 15 degrees the airway shown in Figure 11 (lower line in Figure 12) warmed to above $32^{\circ}F$ (0°C) but at test slopes of 30 and 44 degrees it passed the test (i.e., it remained below $32^{\circ}F$ [0°C] throughout its length). With the bowing of the air barrier, its average height was about 1 inch (25 mm).

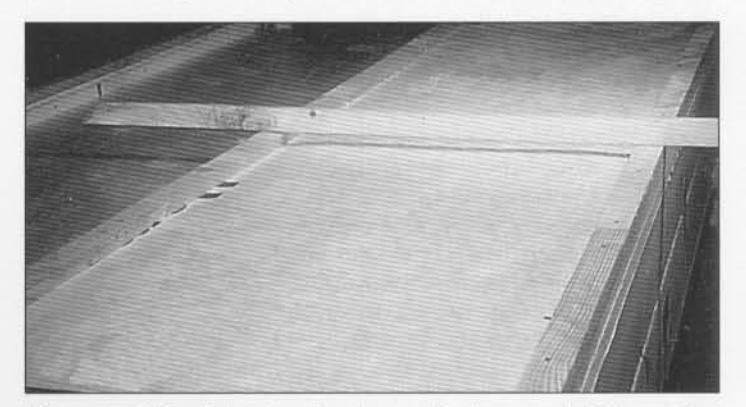
Figure 13. This air barrier, placed over already expanded fibrous glass, was only bowed upward ¼ inch (6 mm).

We investigated one other means of creating "guaranteed" airways using an air barrier over fibrous glass insulation. We removed the air barrier previously discussed and installed a new air barrier on top of 2-inch- (51-mm-) high spacers. We then added ³/₄-inch (19-mm) spacers over it. Figure 13 shows how little that air barrier was bowed by the relaxed fibrous glass. The airway was at least 1/2 inch (13 mm) high across its width. Figure 12 shows that this narrow airway provided inadequate ventilation. Nonetheless, providing space below the airway for expansion of fibrous glass insulation can be beneficial. Air barrier bowing can decrease the effective height of an airway by 1 inch but, by providing space into which the fibrous glass insulation can expand below the air barrier, this loss can be reduced to about ¼ inch (6 mm). Thus, providing space for fibrous glass expansion can create a ³/₄-inch (19 mm) deeper airway when its bottom is an air barrier.

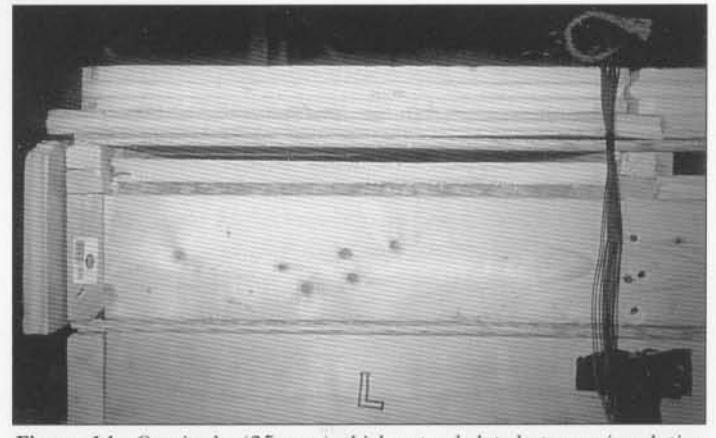
Figure 14. One-inch- (25-mm-) thick extruded polystyrene insulation boards(the light horizontal band below the dark airway) were not bowed by the fibrous glass insulation below. This airway is only ½ inch (13 mm) high. The insulation boards guaranteed its existence. Also note that a gap exists between the plywood roof deck and the "snow" insulation over the right third of this airway. That may explain why the snow insulation provided less thermal resistance than expected.

We constructed guaranteed airways $\frac{1}{2}$, 1 and 2 inches (13, 25 and 51 mm) high using spacers and extruded polystyrene insulation boards. The boards increased the amount of insulation in these tests from about R19 to R24 (3.3 to 4.2 m²K/W). Figure 14 shows the $\frac{1}{2}$ -inch- (13-mm-) high airway.

As Figure 14 shows, the ends of the test airways did not contain inlet and exhaust structures, which would have somewhat reduced airflow up the airways. To obtain an appreciation of how much such features would decrease the ability of these airways, a few tests were re-run with these added. Figure 16 shows the inlet and exhaust structures before they were installed. Each contains two strips, each providing 9.2 square inches of net free openings per running foot (19.5 mm²/running mm). Some tests were run with one strip covered with tape, and others were run with both strips open. Figure 16 shows one strip open and the other covered with tape except at its upper end, so its presence can be detected in the photograph. Figure 17 shows the exhaust structure mounted at the top of an airway that is being tested at a slope of 44 degrees. One of those strips is covered with tape.

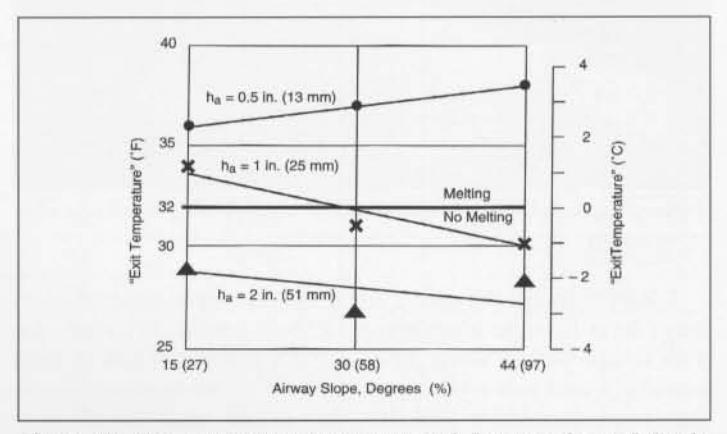
Figure 15. Exit temperature for airways with bottoms of extruded polystyrene insulation boards.

Results of these three tests are presented in Figure 15. The 2-inch- (51-mm-) high airway performed adequately at slopes from 15 to 44 degrees. The 1-inch (25-mm) airway

did not suffice at 15 degrees but it did at slopes of 30 and 44 degrees. This is consistent with the findings for the nominal 1-inch (25-mm) airway created with 2-inch (51-mm) spacers and a bowed air barrier as shown in Figure 11. The ½-inch (13-mm) airway was inadequate at all slopes, as was the nominal ½-inch (13-mm) airway with an air barrier (Figure 13). The slopes of the lines for the 1- and 2-inch- (25- and 51-mm-) high airways in Figure 15 are understandable: As slope increases, these airways perform better. The ½-inch- (13-mm-) high airway, also shown in that figure, does not follow this trend. We expect that the air flow complexities mentioned when discussing Figure 8 explain why this inadequate airway behaves as it does.

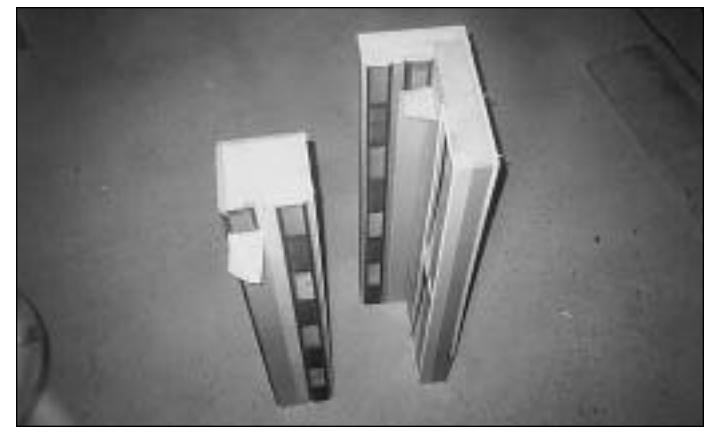
Figure 16. Intake and exhaust structures before being installed on the test roof.

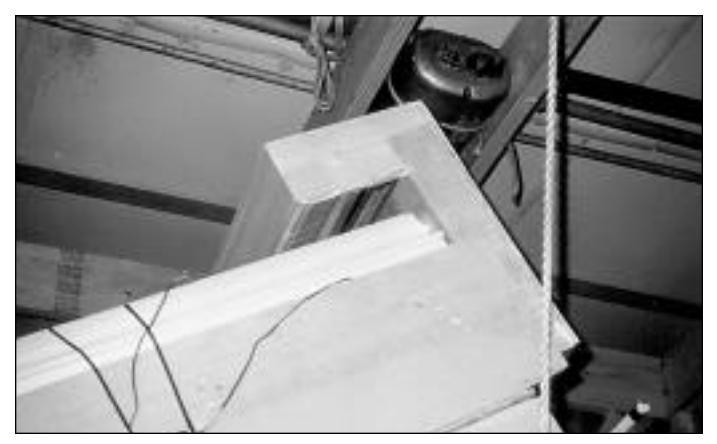
Figure 17. Exhaust structure mounted on airways being tested at a slope of 44 degrees.

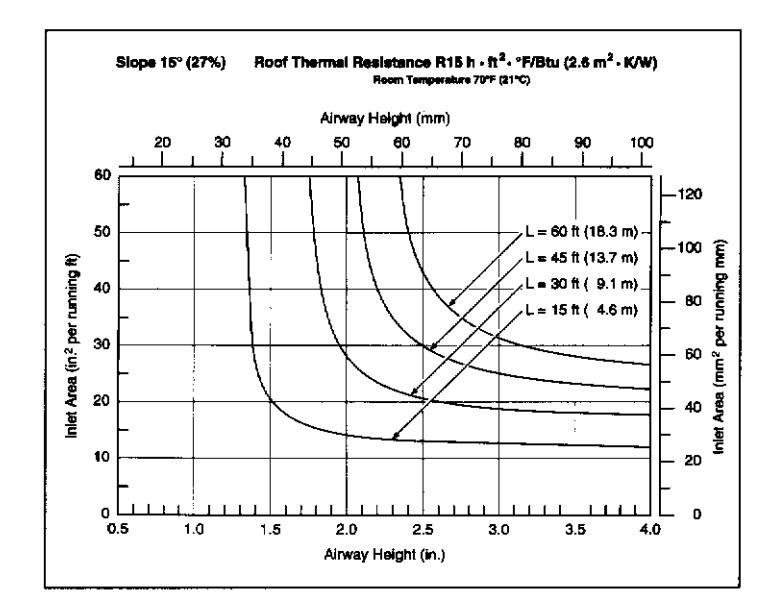
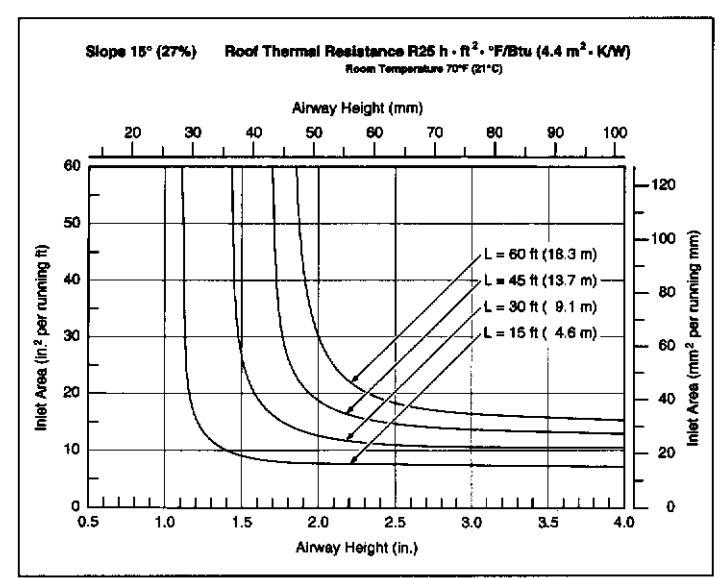
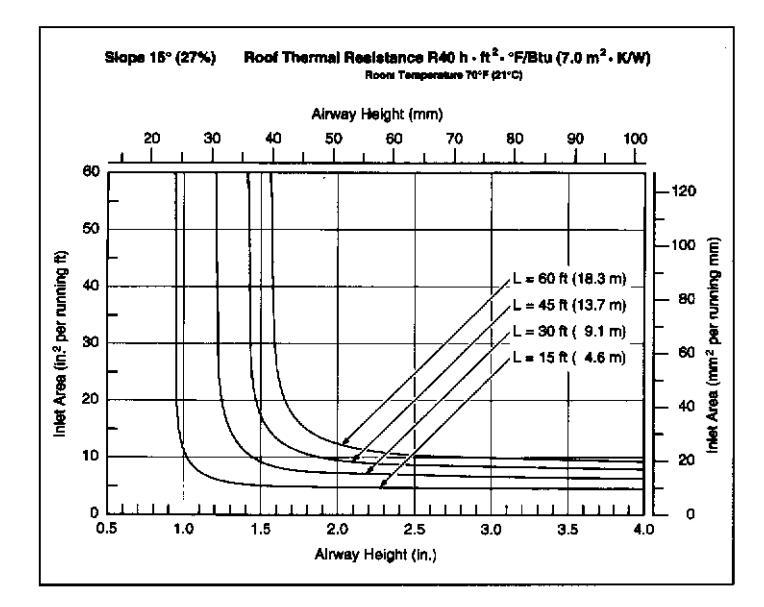
Figure 18. Airway heights and inlet areas for cathedral ceilings with a slope of 15 degrees.

The curves in Figures 18 through 21 were developed for airways located between $1\frac{1}{2}$ inch- (38-mm-) wide rafters spaced 16 inches (406 mm) on center. When rafters are spaced farther apart, the airways occupy a slightly larger portion of the roof area and will perform slightly better. However, because the improvement is minimal, it is suggested that the curves be used unmodified for other rafter spacings.

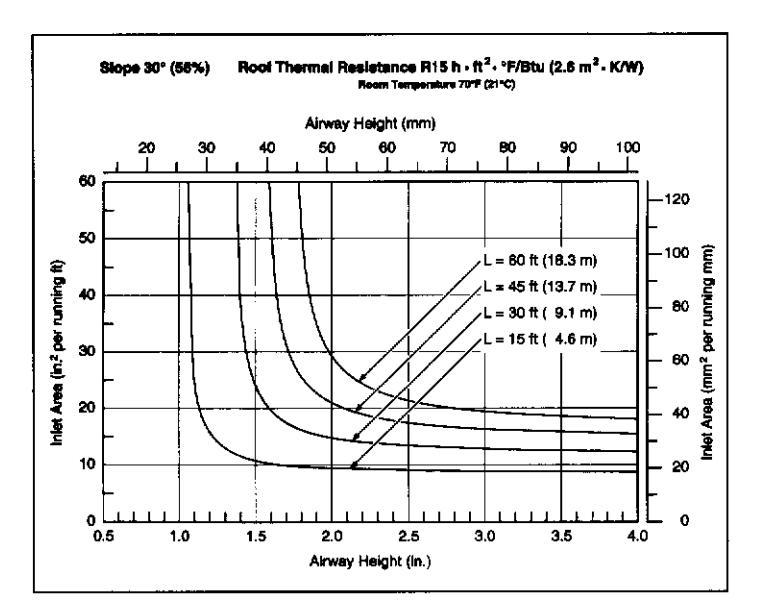
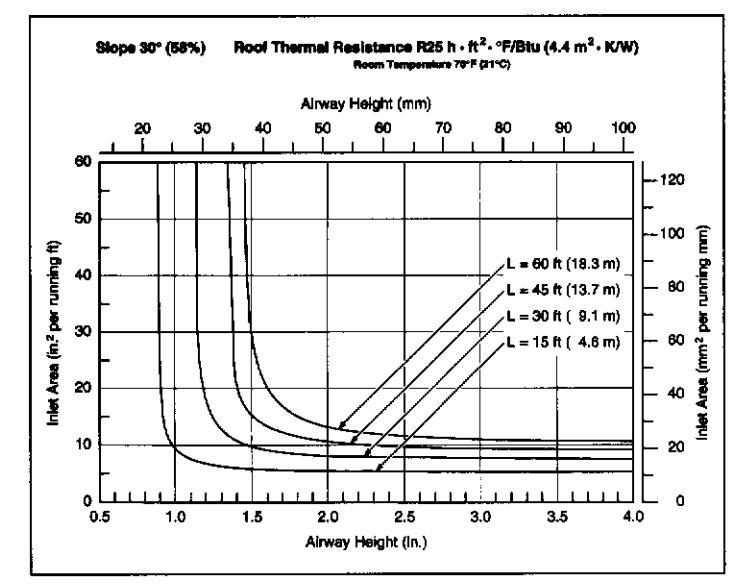
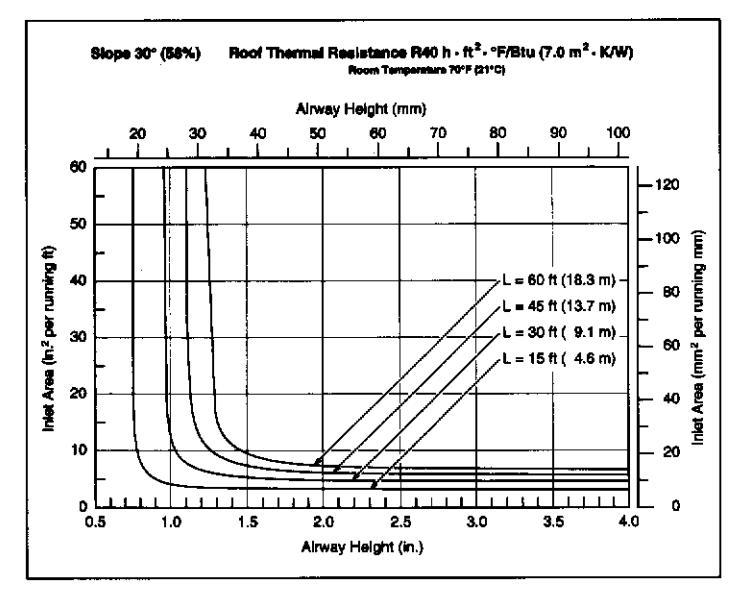
Figure 19. Airway heights and inlet areas for cathedral ceilings with a slope of 30 degrees.

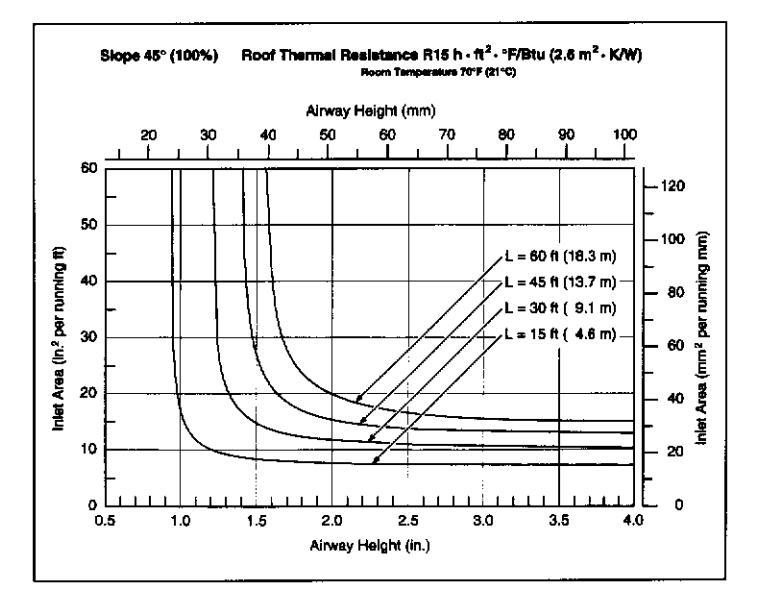
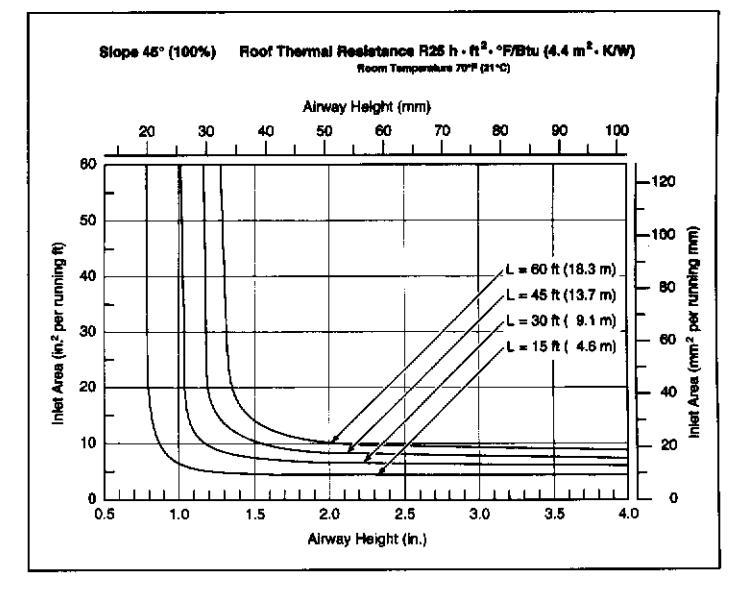
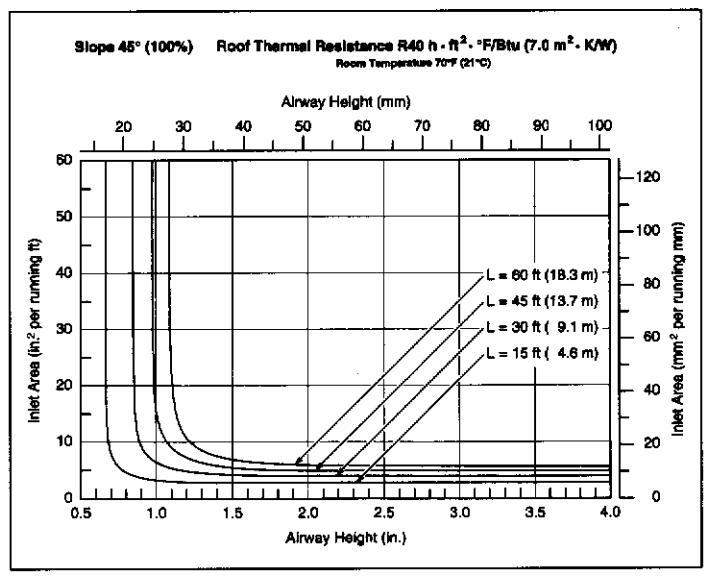
Figure 20. Airway heights and inlet areas for cathedral ceilings with a slope of 45 degrees.

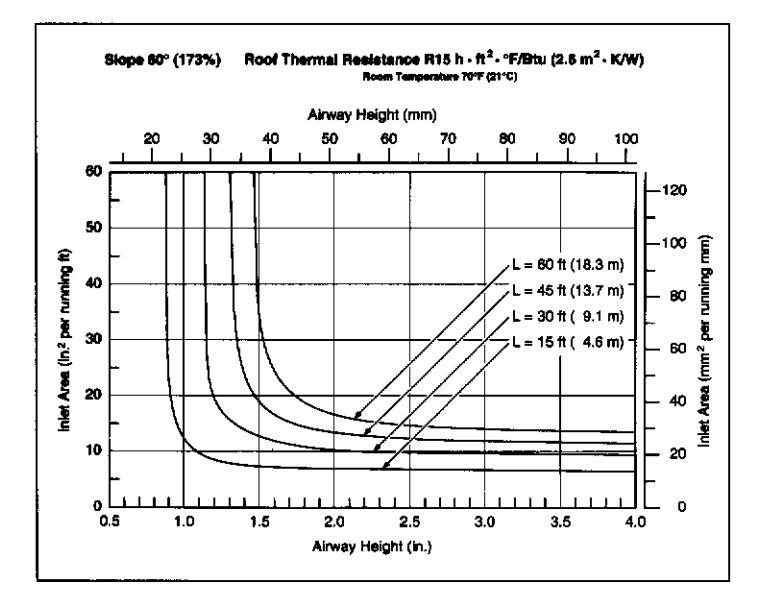
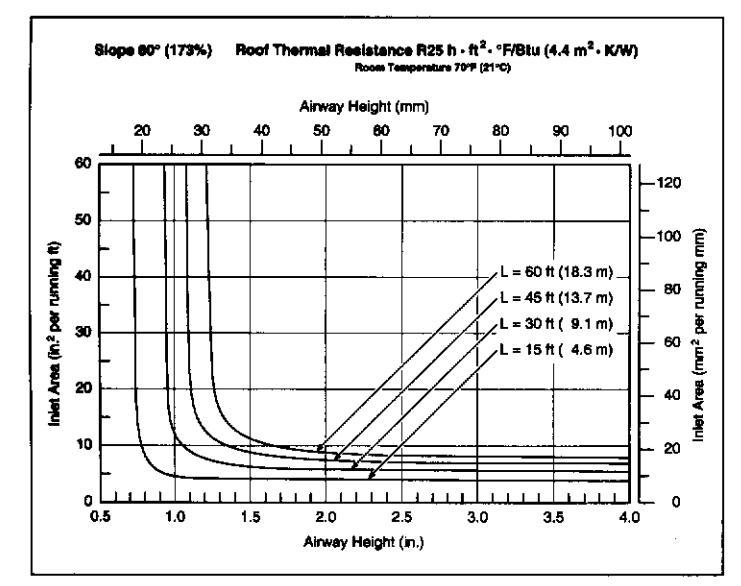
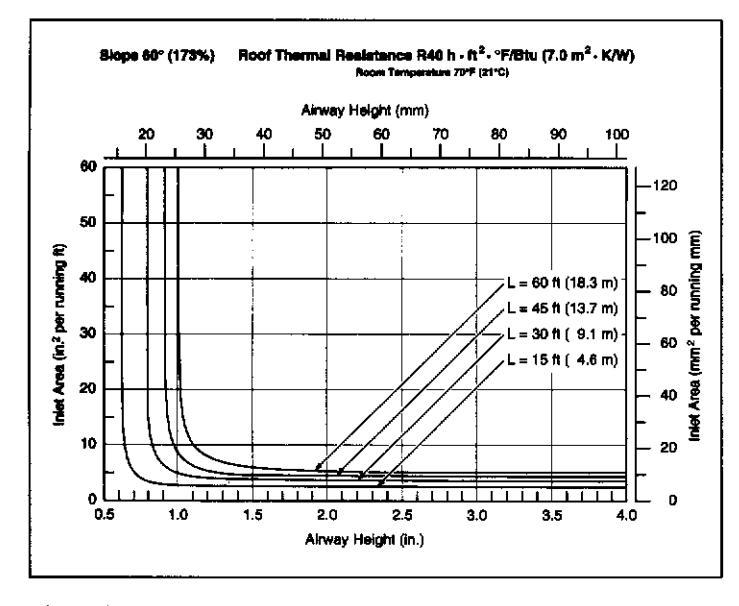
Figure 21. Airway heights and inlet areas for cathedral ceilings with a slope of 60 degrees.
