Sustainability is Nothing New

Larry Meyers Sr. and Carole Ceja Wiss, Janney, Elstner Associates Inc. Chicago, Illinois, U.S.

As labor costs have increased considerably, many of the "modern" advancements in roofing material were created with the sole intention of saving money by reducing installation time. Using the recent reroofing of Few Hall at Duke University, Durham, N.C., as a case study, this paper explores the value of returning to historic precedent to satisfy modern roof system performance requirements, and it shows that sustainability is nothing new.

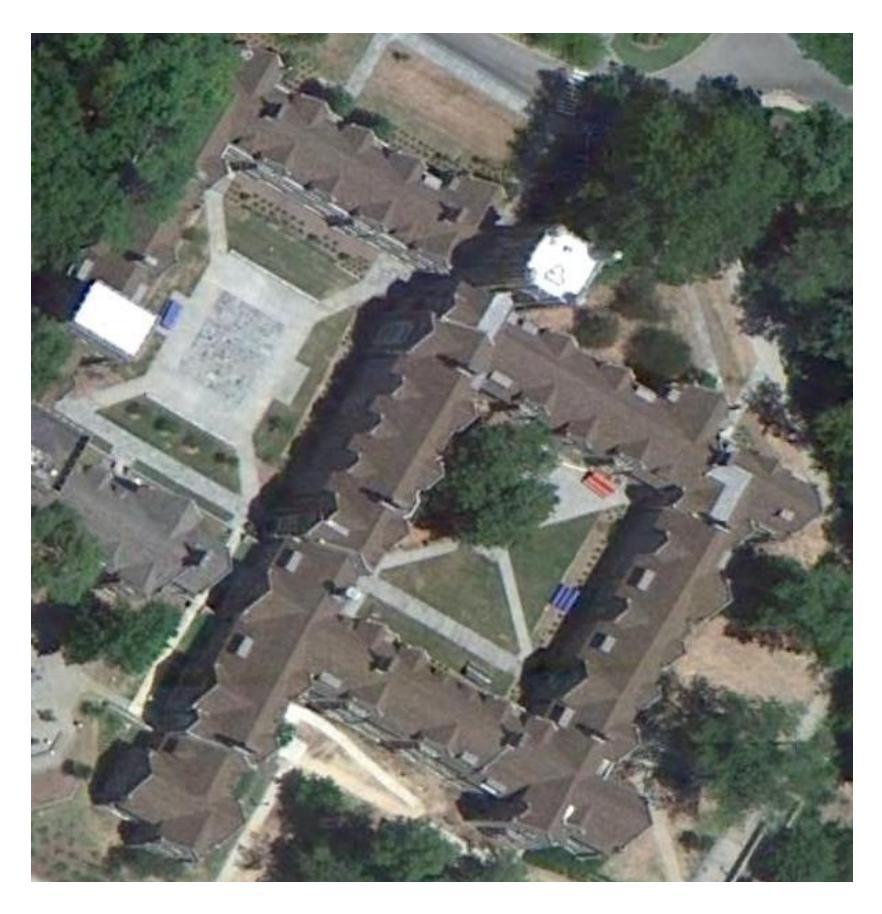
Figure 1. Overview of Few Hall, Duke University, Durham, N.C.

Few Hall was constructed in the late 1930s as a residential dormitory for students staving at the Duke University campus. See Figure 1 for an overall view of the building. The building is a complex series of wings oriented primarily around two interior courtyards. Each wing contains a primary gable running along the long axis. A series of secondary gable and smaller dormers intersect the main gable at the student rooms. The gables and dormers are roofed in Ludowici Roof Tile™ (Ludowici) Yale style clay tile units. Hanging copper gutters and built-in copper gutters collected rain water runoff and directed it to elaborately crafted copper conductor heads and downspouts before entering the below-grade storm water system. The 14:12 (average) pitch roof uses closed valleys and copper baby tin flashings and counterflashings which were molded against the rough-hewn Duke Stone exterior building walls to reflect the texture of the stone's surface below (see Figure 2). Few Hall is a large building with an approximately 54,600-square-foot roof, but it is also a part of a larger collection of buildings that comprise the West Campus of Duke University. The roof lines are a vital piece of the campus's architectural expression, and the scale of Few Hall with its textured dormers sets it apart as a residential building among the greater campus of education buildings (see Figure 3). The enduring institution of Duke University is etched into the rock of the walls, which ties successive generations of students together in a common living and learning experience.

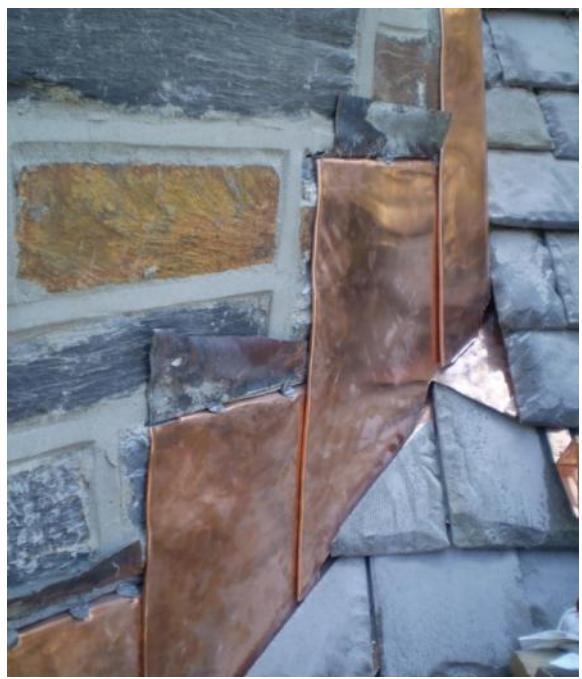
Figure 2. New copper flashings to Duke Stone at exterior walls and chimneys

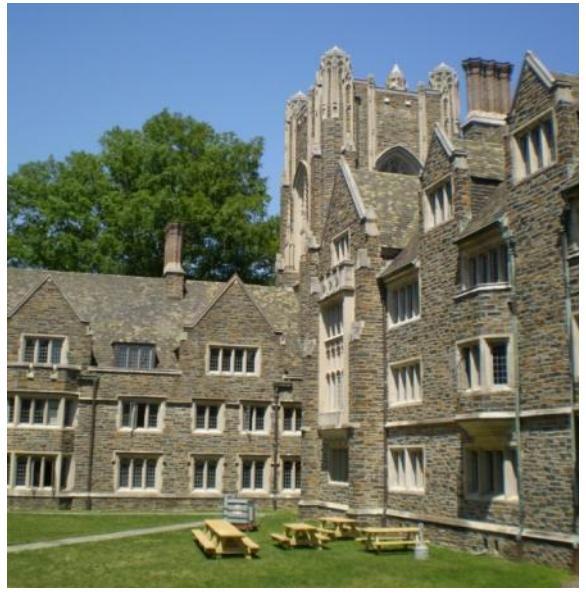
Figure 3. Few Hall, a residential building with secondary gables, dormers and balconies

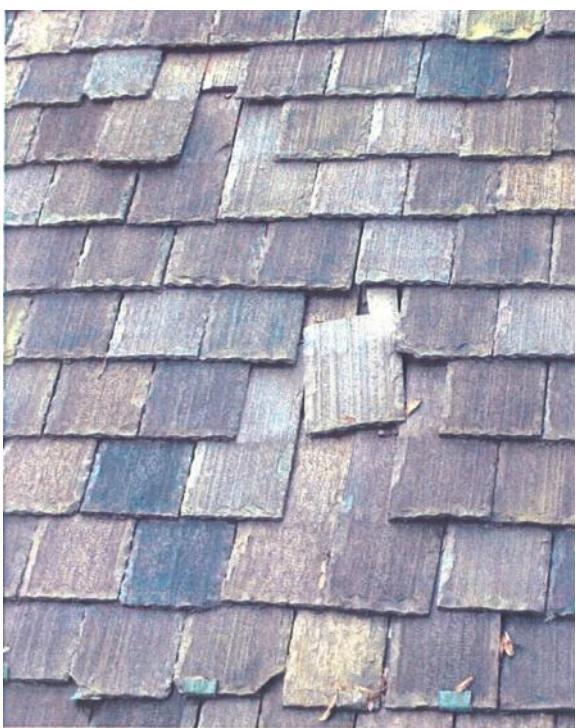
During the investigation, several tiles were removed and tested for breaking strength according to ASTM C1167, "Standard Specification for Clay Roof Tiles" and for water absorption as referenced in ASTM C67, "Standard Test Methods for Sampling and Testing Brick and Structural Clay Tile." These two tests evaluate a clay tile's weathering resistance. The testing revealed that although all of the tile samples passed the water absorption criteria, more than two-thirds of the samples failed to meet current standard requirements for breaking strength. There were no ASTM International standards for fabrication or performance of clay roof tiles at the time a roof system first was installed on Few Hall. In fact, there was no ASTM International standard (for clay roof tiles) adopted before 1990. Because there was no attic stock available from the original installation, it could not be determined whether the existing tile units had lost strength over time or that the original fabrication values were less than current standard requirements.

Figure 4. Typical types of observed damage to original tiles in service for more than 70 years

Because of the high potential for ongoing deterioration of the existing tile units, the recommendation to Duke University was for full replacement of the clay tile roof system and copper accessories within the next two to five years. Duke University had planned a major interior renovation project for Few Hall and determined that commencing the roofing work immediately would be beneficial and protect the new interiors. Completed design drawings and specifications were provided to Baker Roofing (Baker) who had engaged in a negotiated contract with Duke University. Construction began in January

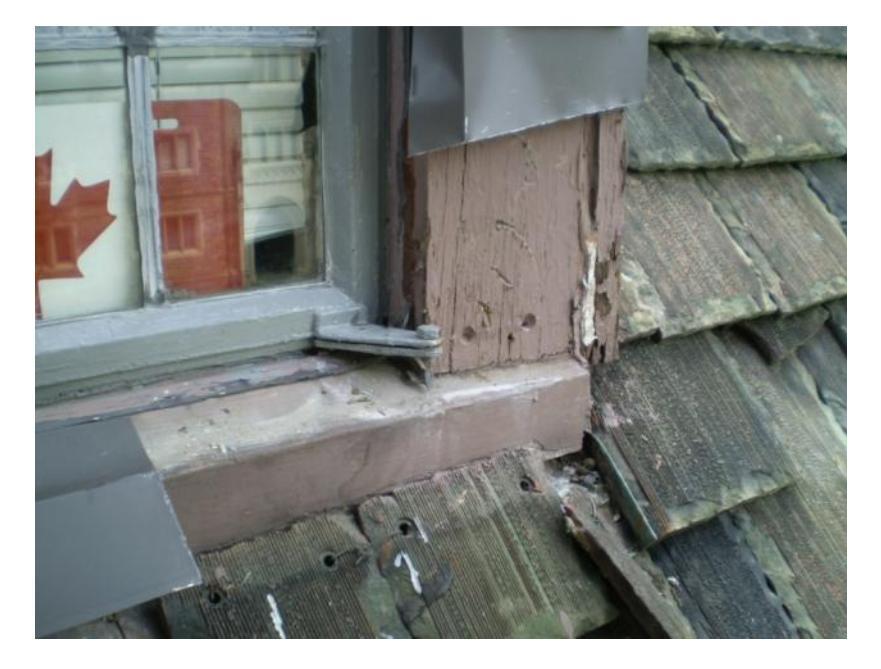
Figure 5. Wood-framed windows below existing

aluminum covers

The dormer windows were constructed with wood frames. At some point, the maintenance of these windows necessitated the installation of aluminum covers to minimize the ongoing deterioration of the wood and peeling paint (see Figure 5). The reroofing project included replacing these aluminum frames. Aluminum also is a highly recyclable material, and the aluminum window casements were sold to TT&E Recycling rather than ending up in a landfill.

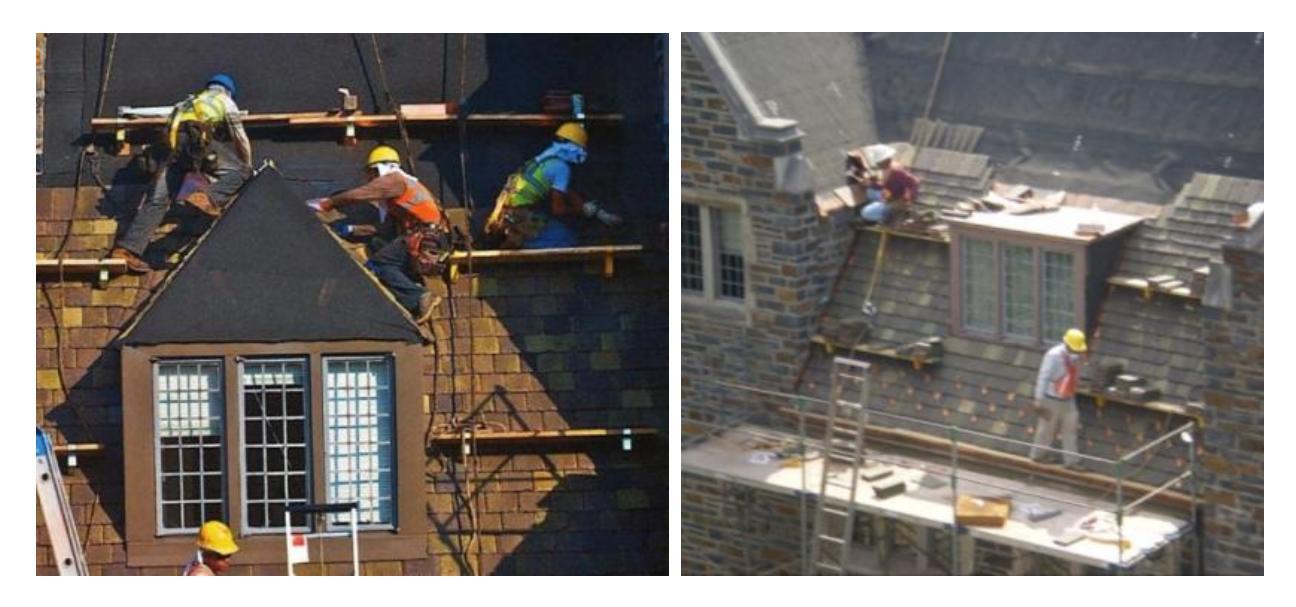
Figure 6. Many hands were involved in tile installation at dormers.

Ludowici is the largest employer in Perry County, Ohio, and Baker employed more than 70 men on-site. By the time each tile was in its final position, at least eight hands had helped it along its path (see Figure 6). Each tile was created for a specific location on the roof and production followed installation scheduling. During the 180 days of installation, Ludowici could produce fire and ship only the combination of tiles shapes

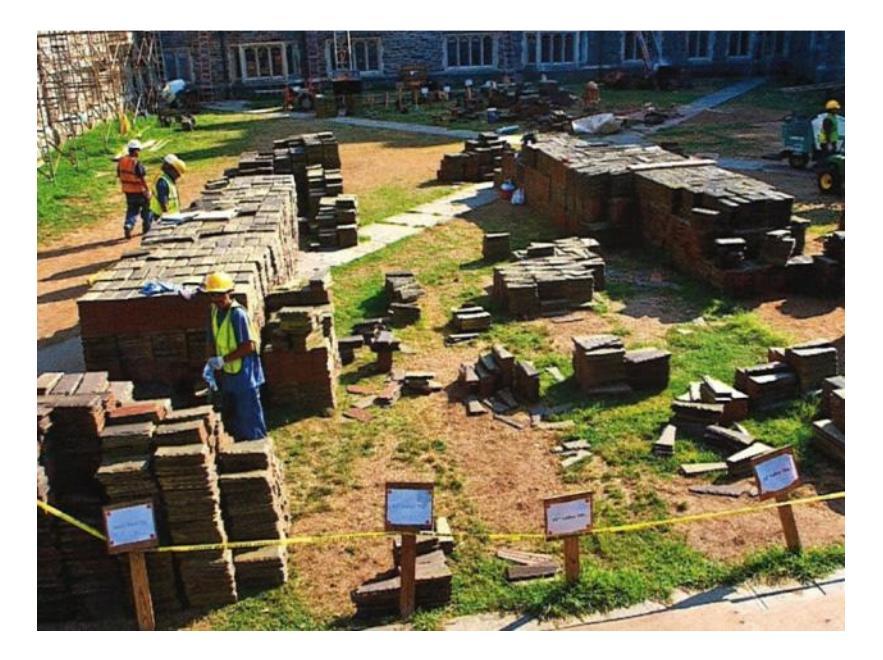
Figure 7. Many hands were involved in tile sorting for color blend and size.

and colors needed for the area of the roof being completed by Baker at that time. This limited the necessary staging space (in turn, damaging less mature landscaping). Color blending of the tile units was carried out on-site by hand because no machine could achieve the artistry needed to blend the three colors of tiles included in the design (see Figure 7). Installation work also was hand-oriented, from raising the tiles to the roof level 10 tiles at a time to laying out the complex patterns of closed valleys (see Figure 8), each valley requiring more than five different sizes of tile.

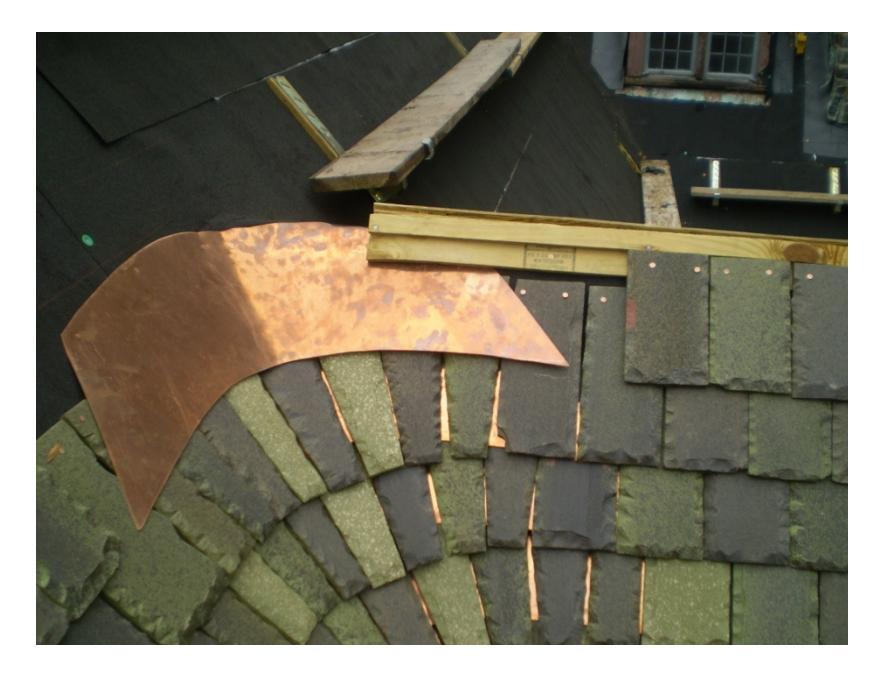
Figure 8. Complex closed valley design and intersection ridges created significant detail work and opportunity for artistry of craft for tile layers, including the even distribution of three tile colors.

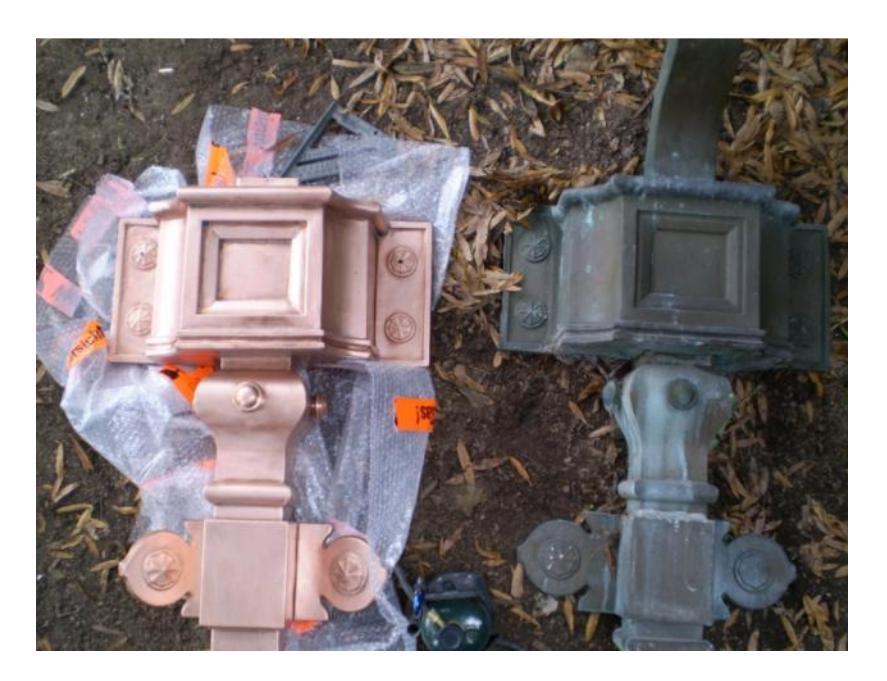
Figure 9. New (left) and original (right) conductor heads

The connection created to the past through the continued use of the historic clay tile roof system is one way the project is sustainable even if it is difficult to quantify the effects. The longer a building is in place, the greater importance it develops in the community. With the highly visible roof configuration establishing the character of the campus, Few Hall's roof becomes a symbol of Duke University's commitment to honoring the past. The uninterrupted appearance of Few Hall over what will total more than a century and a half adds value to the project and community as a whole. Duke University also always was cognizant of the roofing project's effect on its alumni network and how alumni often are interested in owning a piece of their past. One of the strategies employed by Duke University to defray the costs of the reroofing project was to save the original ornate copper conductor heads for possible sale to benefactors in the future (see Figure 9).

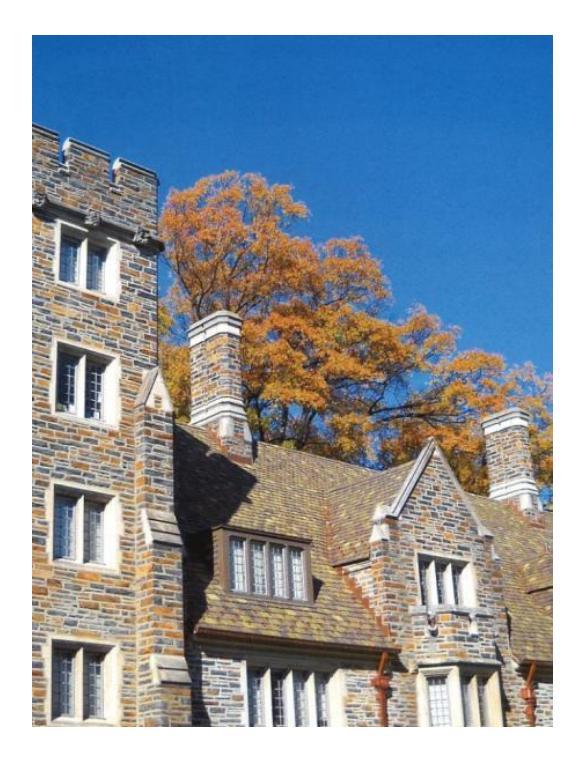
Figure 11.

Portion of

completed

roof line.

sustainability are nothing new. The result was a beautiful, high-performance roof system (see Figure 11).
