MEMBRANE IMMERSION TEST: MODIFIED BITUMEN MEMBRANE ASPHALTIC IMPREGNATION EVALUATION

PHILIPPE THIRIAUX and D. G. PERKINS

Performance Roof Systems, Inc.
Kansas City, Missouri

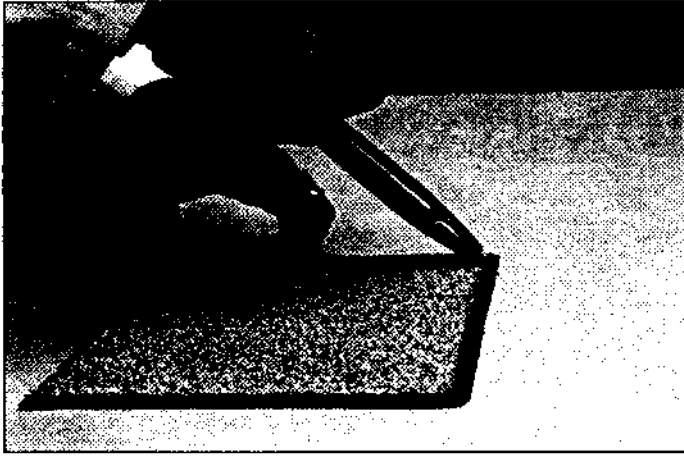
Figure 1. All four edges are herfed diagonally (45-degree angle) to expose the reinforcement.

- A 0.25-m by 0.25-m (10- by 10-inch) square sample is prepared from the membrane to be tested.
- All four edges are kerfed diagonally (45-degree angle) to expose the reinforcement (see Figure 1). The reinforcement must be visible to simulate cuts made during application.
- The sample is submerged in a water bath at 60°C (140°F) for 14 hours (see Figure 2).
- The sample is removed from the water bath and allowed to dry at room temperature (23°C±3°C [73°F±5°F]) for 30 minutes.
- The sample is then placed in an oven (see Figure 3), preheated to 230°F (110°C), for 30 minutes. Note: This test will not provide accurate results for some membranes

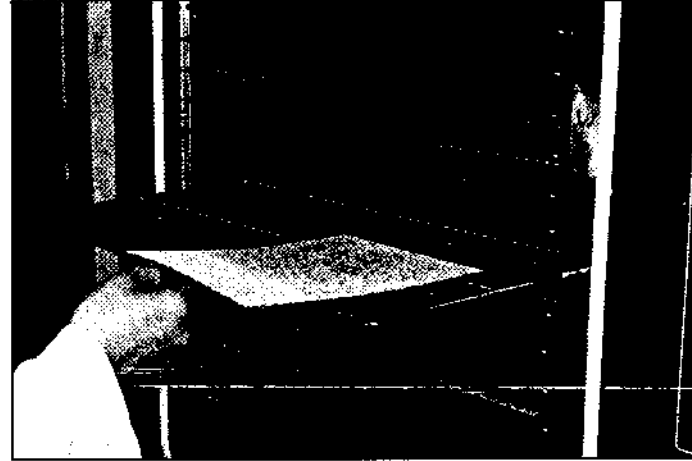
Figure 3. The sample is then placed in an oven, preheated to 110°C (230°F), for 30 minutes.

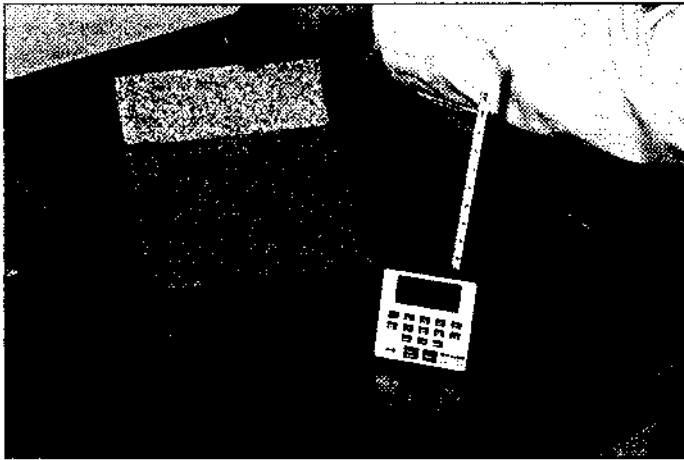
Figure 2. The sample is submerged in a water bath at 60°C (140°F) for 14 hours.

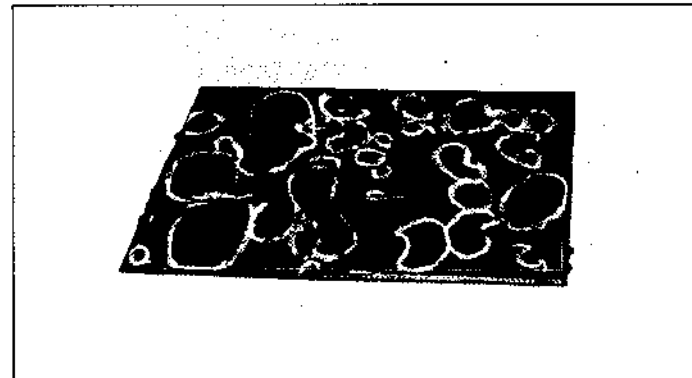
Figure 4. The sample is removed from the oven and visually analyzed. White marks highlight blisters.

- The sample is removed from the oven and visually analyzed as discussed in the following section (see Figure 4).

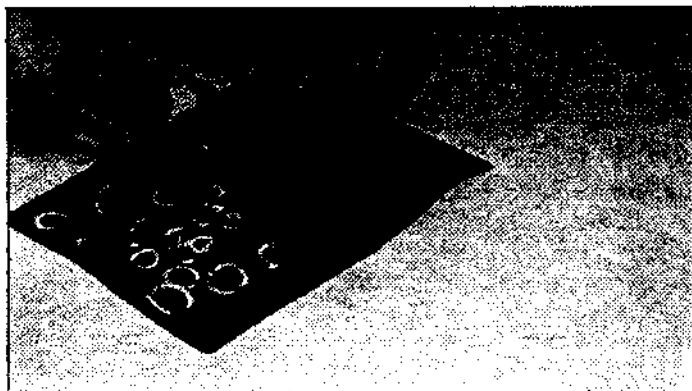
Figure 7. Complete delamination of the blend from the reinforcement.

Samples with inadequate impregnation may exhibit a total delamination of the asphaltic blend from the reinforcement (Figure 7).

In addition to the tests discussed previously, other exploratory tests were made on reinforcements containing excessive amounts of binder. If the reinforcement fibers or strands have been heavily coated with excessive binder during manufacture, the finished reinforcement becomes coated by a continuous layer of binder. In some instances, the melting point of the binder is higher than the final impregnation temperature during membrane manufacture. The binder layer remains intact, and the heavy coating of binder acts as a barrier and will not allow a thorough impregnation of the reinforcement, because the blend cannot pass through the mat. When this type of product is subjected to the MIT, a complete delamination of the blend from the reinforcement (Figure 7) can occur.

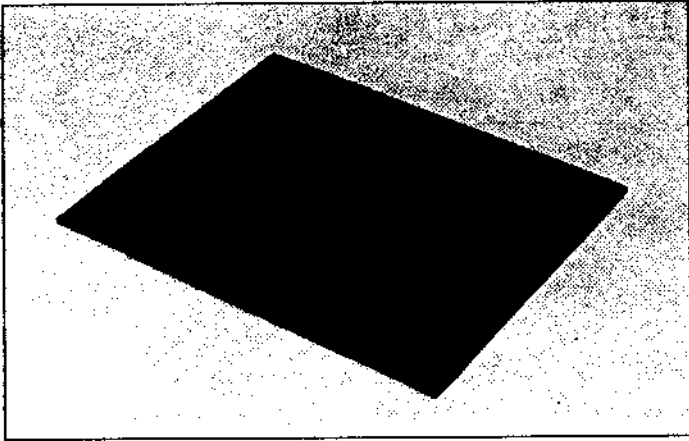
Figure 8. Sample B after MIT.

MIT Test Results:		
Sample	Blisters	Delamination of the scrim
A (Figure 5)	70%	yes
B (Figure 8)	0%	no
C	35%	no
D	0%	no
E	0%	no
F	70%	yes
G	0%	no
H	50%	no
I	0%	no

between Sample A with polyvinyl alcohol binders and Sample B with the SB latex/urea binder. The former binder is water-soluble, and the latter is emulsified. The curing (or drying) temperature of the reinforcements during manufacture for Sample A was not high enough to dry the polyvinyl alcohol binder. During the oven test, the residual moisture in the Sample A finished reinforcement was determined to be higher than 2 percent (minimum moisture content for PVA even "dry"—moisture is easily picked up from the ambient humidity). Moreover, as the reinforcement in Sample A is directly exposed to water for 14 hours in the MIT water bath, the binder is hydrated, and water is transported into the roofing membrane by capillarity. At 110°C (230°F), in the MIT oven test, the residual moisture present in the uncured polyvinyl alcohol binder of Sample A begins to boil, and a complete delamination of the blend from the reinforcement is seen. In addition, there is a complete delamination within the reinforcement of the scrim from the fiberglass mat.
