## **Beyond 20-Year Low-Slope Roof Performance**

### **Gary C. Patrick, AIA, CSI**

#### **Abstract**

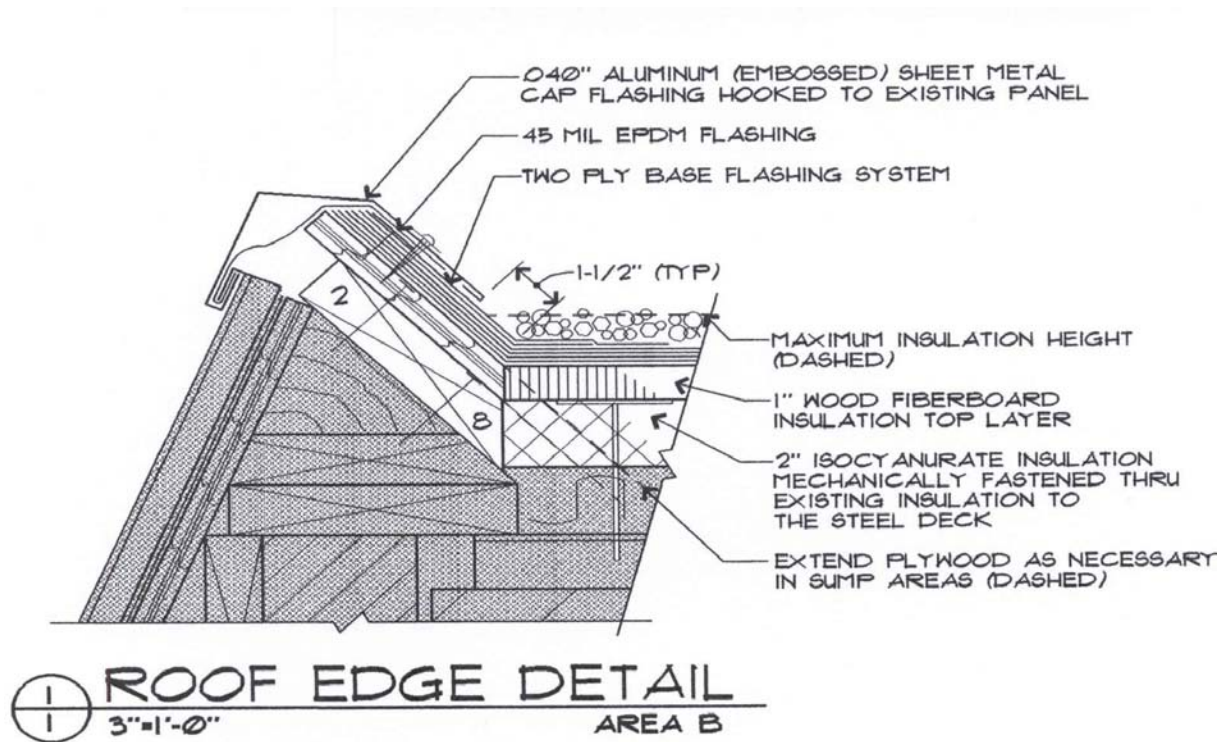
Design Detail Example, 25-Year Roof

- Ponding elimination via tapered insulation, added drains or sloped structure.
- In the built-up roof system, 1 inch (25 mm) thick wood fiberboard or perlite insulation beneath membrane. 4- by 4-foot (1.2- by 1.2-meters) maximum insulation size. Multi-layer insulation.

- Eight inch (203mm) minimum base flashing heights (except at canted roof edge design). No gravel-stop roof edge sheet metal.
- Sheet metal flashings designed to meet Factory Mutual Research. Concealed flashing (i.e., EPDM) beneath sheet metal.

- 3 inches equals 1 foot, 0 inches (76mm equals 304mm) scale details.
- Details designed with solid wood blocking to support the roof components.
- Roof system technical specifications following Construction Specific Institute (CSI) format.
- Construction document preparation under direct supervision of a licensed professional engineer or architect.
- Pre-bid conference with contractors and building owner prior to opening bids.

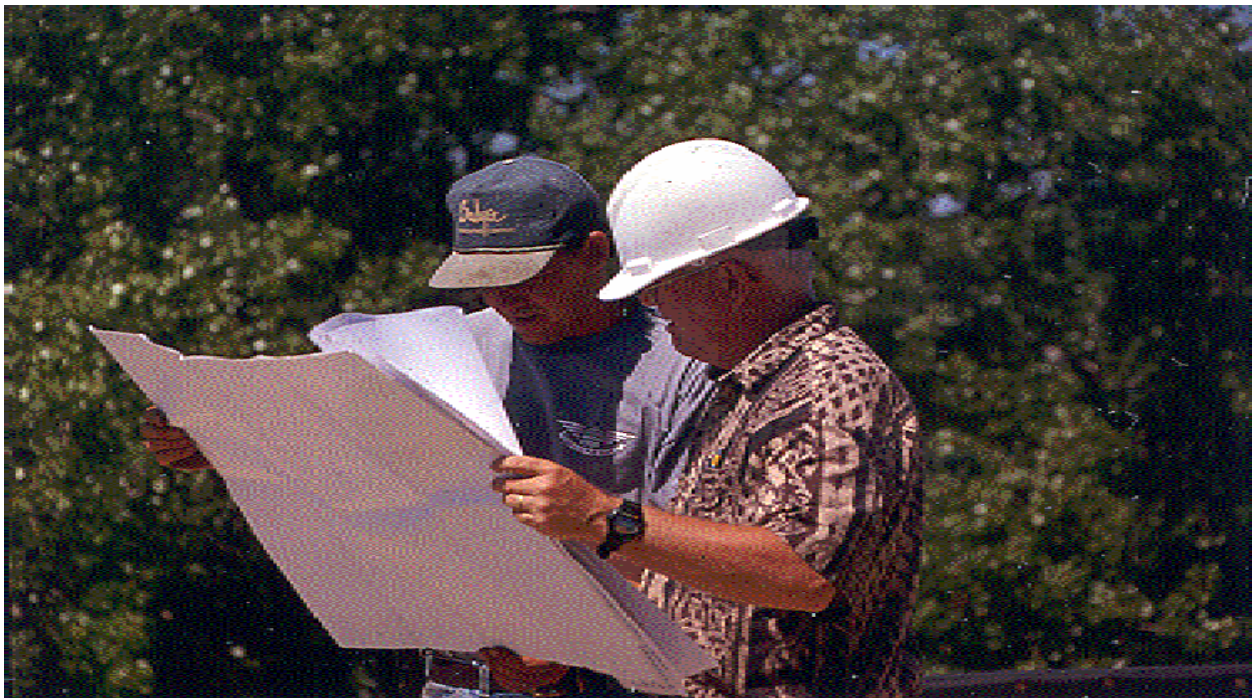
Reviewing construction documents during an inspection.

- Testing of materials and review of submittals prior to construction.
- Reviewing construction documents with the roofing foreman.

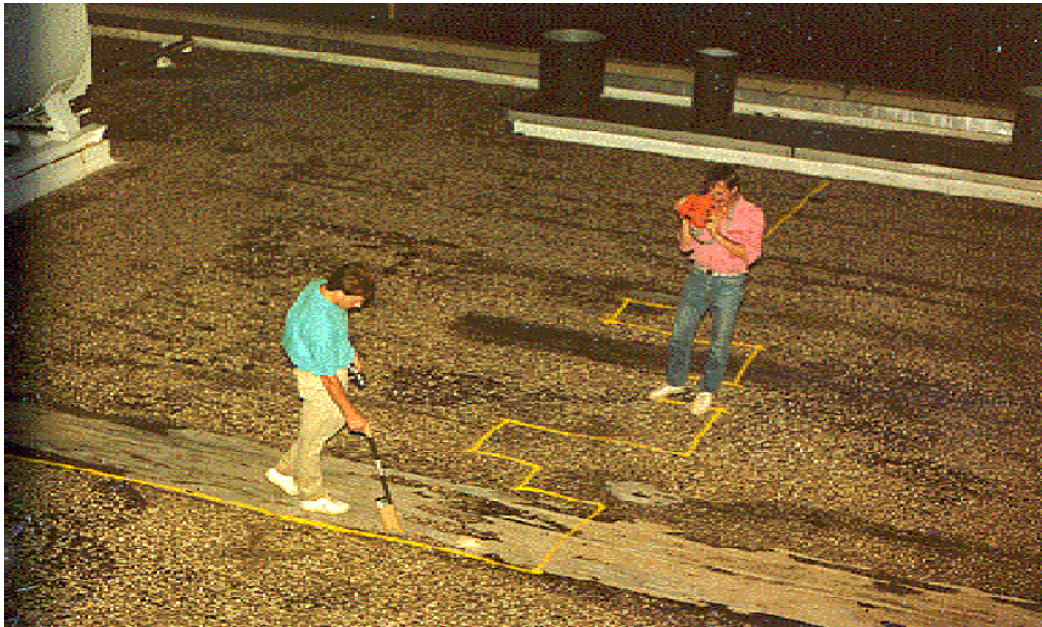
Infrared Evaluation

- Annual roof system walkovers by a trained person.
- Infrared evaluation (on applicable system) every two years.

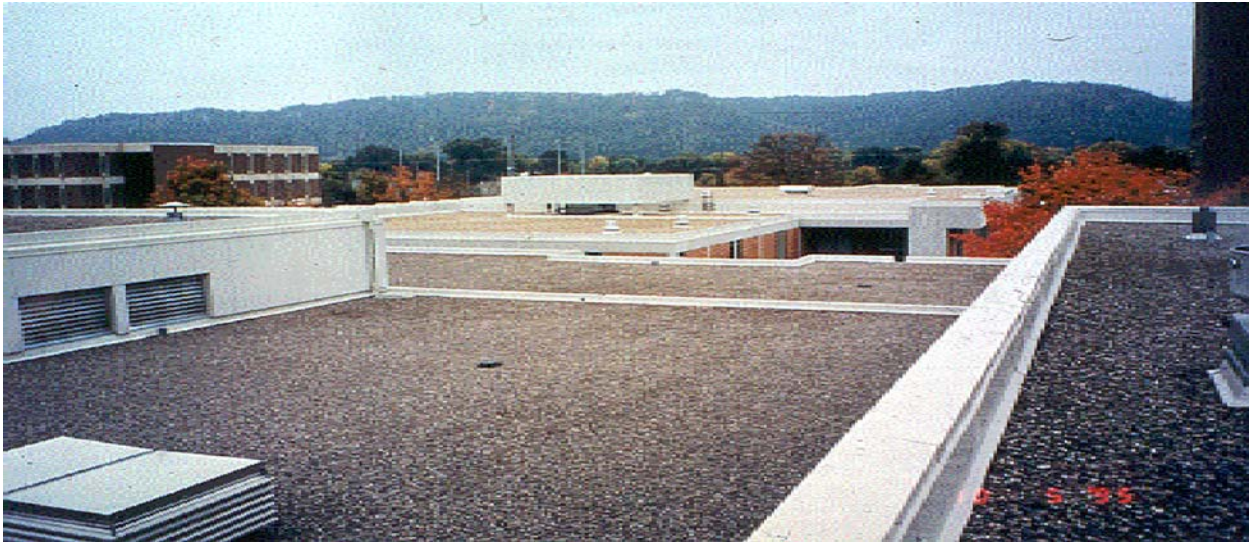
A typical MnSCU Standard Roof (MSR)

In the late 1980s, based on the author's roof system performance experiences and the program's goal, the gravel-surfaced built-up roof system became the preferred roof system. The author was predicting 25 years of service life and the roof system was identified as the Minnesota State University System Standard Roof (MSR).

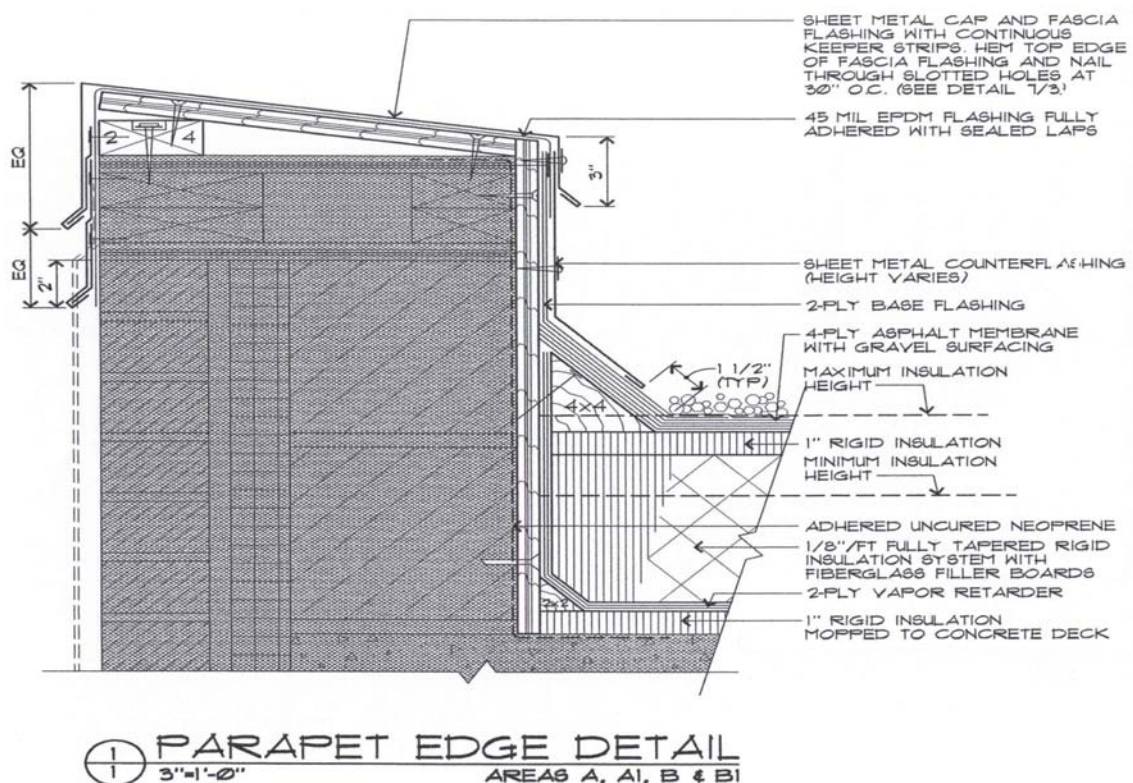
Design Detail Example—MSR

- Unobstructed positive slope to drain (i.e., drains added, roof top equipment relocated).
- Roof system R-value of between 25 and 30. A vapor retarder is required.
- Roof penetrations minimized. 12" (305mm) minimum base flashing heights created. No gas lines or electrical piping runs permitted on the roof.
- No "or equals" in the specification.
- Material performance history of 10 years minimum.
- Details that could allow moisture entry from an adjacent condition (i.e., window or door sill, a skylight) incorporate a membrane to envelope the roof system.

- Through-wall flashing, window and door sills are to be a minimum of 24" (610mm) above the deck (new construction).

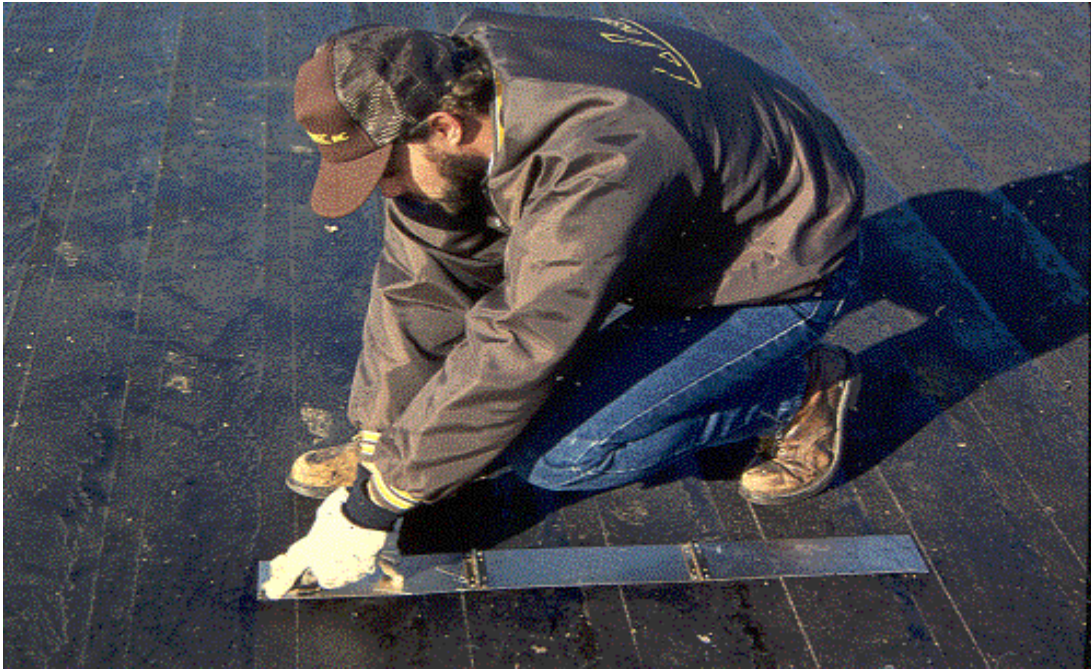
Roof Membrane Test Cut

- Coordination of sub-consultant's inspections.
- No surprises for the owner.
- Membrane test cuts for analysis of material weights, lapping and lamination.

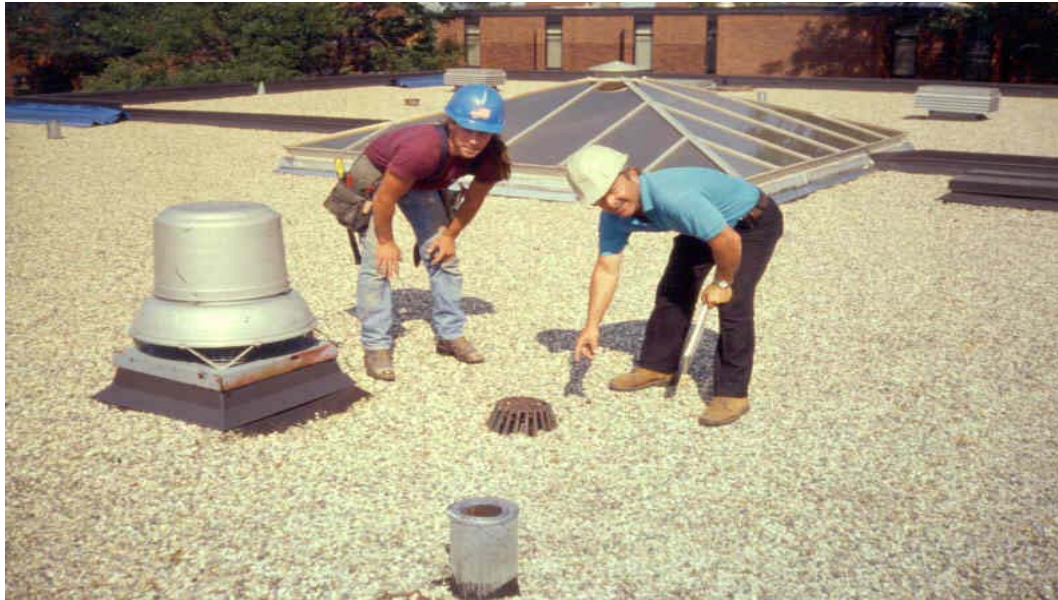
Annual Roof Survey

- The facility shall maintain historical records for each roof system.
- The facility should visually inspect roofs immediately following severe weather, documenting any signs of damage and schedule repairs as soon as possible.
- Annual roof survey conducted by a MnSCU designated Roofing Consultant. These will include infrared roof moisture surveys and a comprehensive report. Schedule repairs as soon as possible.
- Verify that roof access is minimized and that roof drainage is unobstructed.
- Check and secure any loose metal flashing.
